Valve

VB-9313 Series 2-1/2" thru 3" Screwed End, 2-1/2" thru 6" Flanged End Mixing Valves

MAINTENANCE PARTS

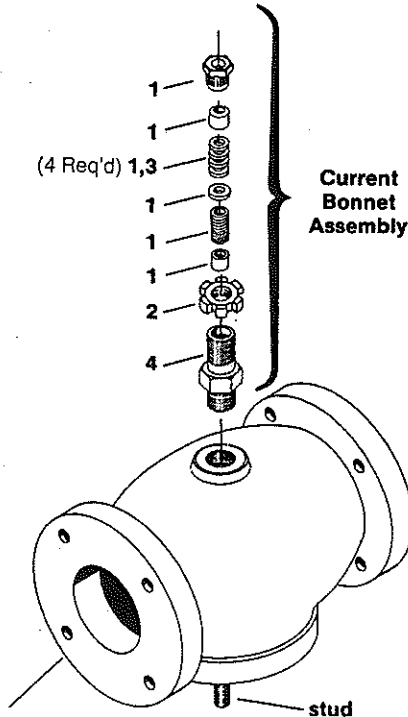
Current Bonnet Assembly

*Replace with current bonnet assembly (YBA-652) if any of the old style packing components — no longer available — require replacement. The old style bonnet assembly can easily be identified by noting the large hex head packing gland nut with internal threads.

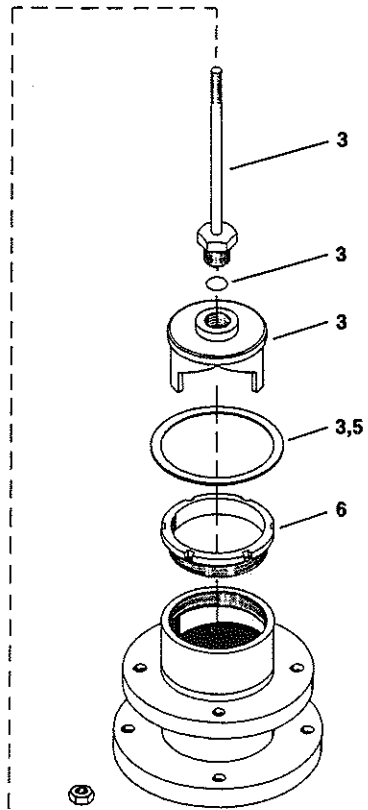
VB-9313

Valve Body Part No.	Size & Port	Packing	Bracket Nut	Valve Repair Kit Includes Packing Stem & Plug Assm. Bottom Gasket	Current Bonnet Assembly* Includes Packing & Bracket Nut	Bottom Gasket	Seat Ring**
	Item No.	1	2	3	4	5	6
VB-9313-0-4-12	2-1/2" Port 12	YBA-651-1	OYBB-225	RYB-931-12	YBA-652	BYRZ-13-12	RYB-9213-101-0-12
VB-9313-0-4-13	3" Port 13	YBA-651-1	OYBB-225	RYB-931-13	YBA-652	BYRZ-13-13	RYB-9213-101-0-13
VB-9313-0-5-12	2-1/2" Port 12	YBA-651-1	OYBB-225	RYB-931-12	YBA-652	BYRZ-13-12	RYB-9213-101-0-12
VB-9313-0-5-13	3" Port 13	YBA-651-1	OYBB-225	RYB-931-13	YBA-652	BYRZ-13-13	RYB-9213-101-0-13
VB-9313-0-5-14	4" Port 14	YBA-651-1	OYBB-225	RYB-931-14	YBA-652	BYRZ-13-14	RYB-9213-101-0-14
VB-9313-0-5-15	5" Port 15	YBA-651-1	OYBB-225	RYB-931-15	YBA-652	BYRZ-13-15	RYB-9213-101-0-15
VB-9313-0-5-16	6" Port 16	YBA-651-1	OYBB-225	RYB-931-16	YBA-652	BYRZ-13-16	RYB-9213-101-0-16
